Richland County Macroburst and Tornado Event July 29, 2011 National Weather Service Glasgow Storm Survey Summary

Results From Damage Survey

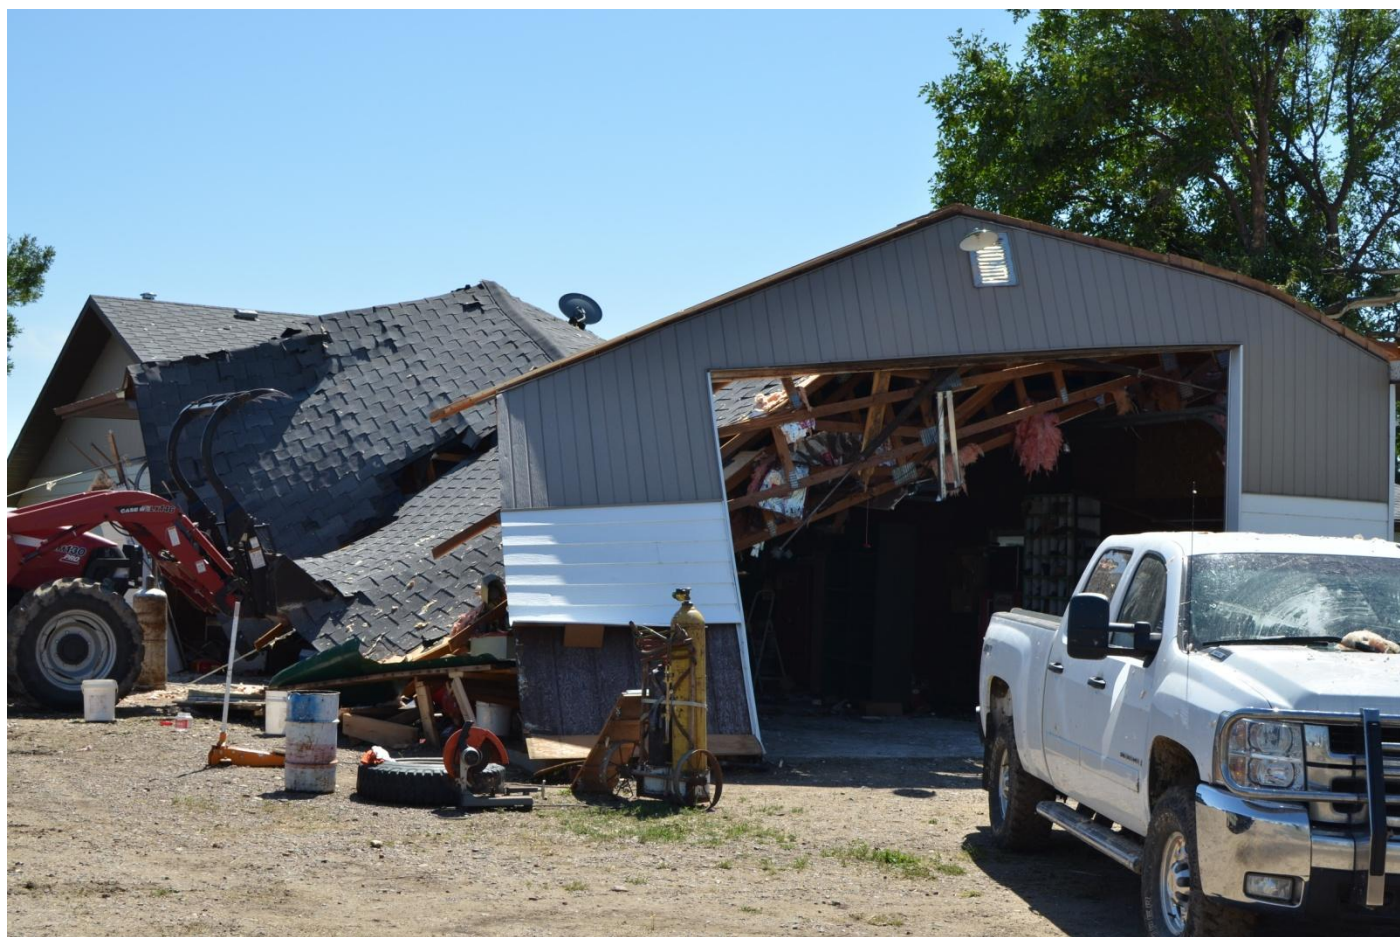
Fig. 1. Damage to attached garage of a house west of Savage, MT. Garage door and garage wall on left side of photograph were ripped off and deposited some 200 feet downwind.

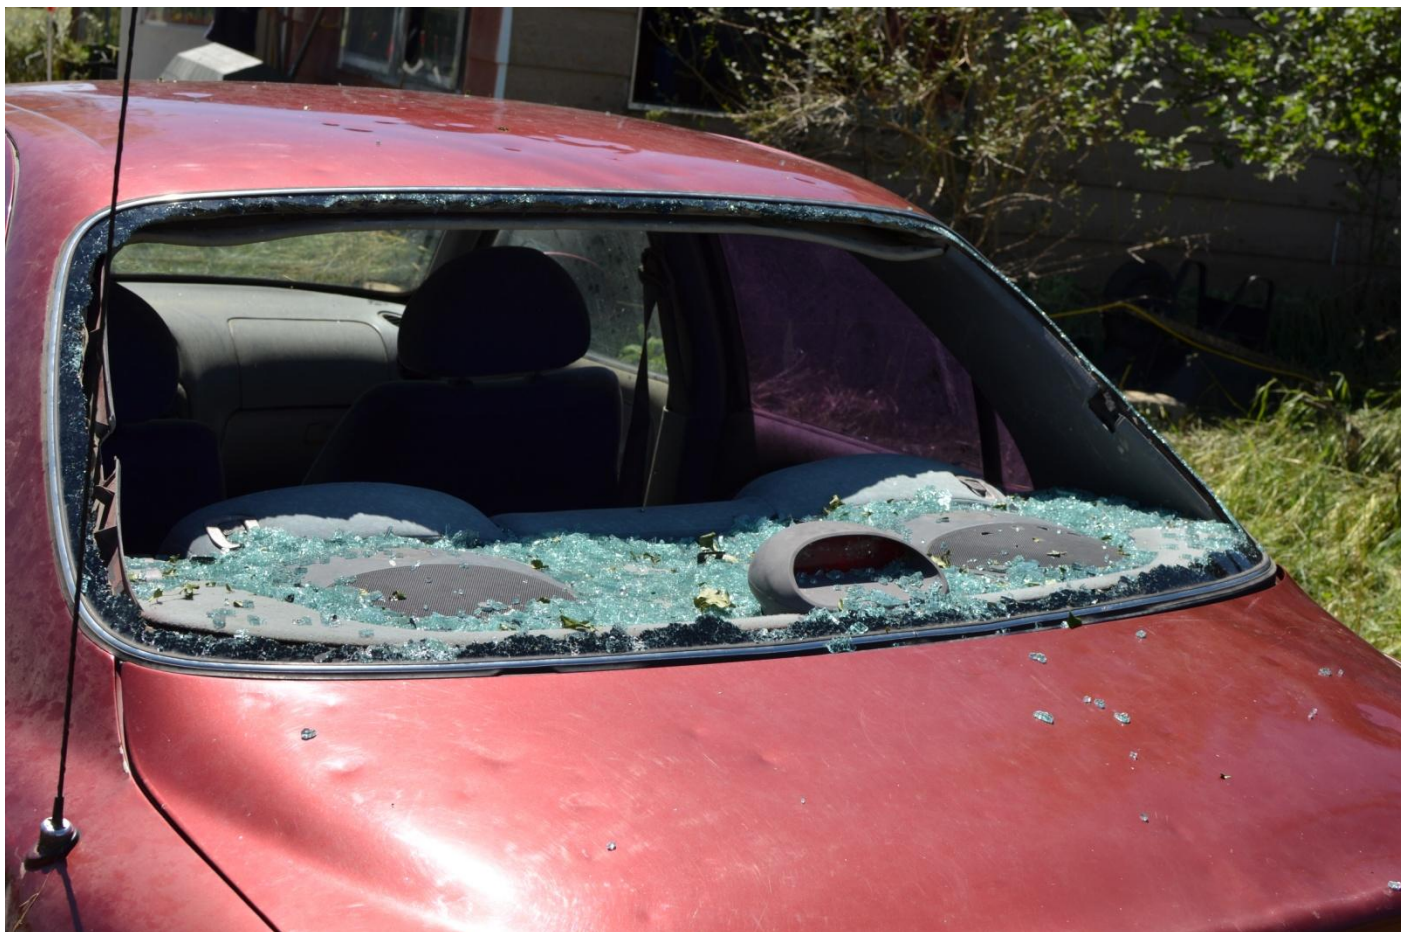
Figure 3. Car damaged by hail on Rd 115 southeast of Lambert

Some light damage consisting of tree branches down and fence damage was noted south of Lambert. More significant damage was found about 9 miles southeast of Lambert on Rd. 115. At this location, numerous trees were uprooted or snapped (Fig. 4), and there was damage to homes and vehicles (Fig. 3). Residents reported hail up to 2.5 inches breaking windows in homes.

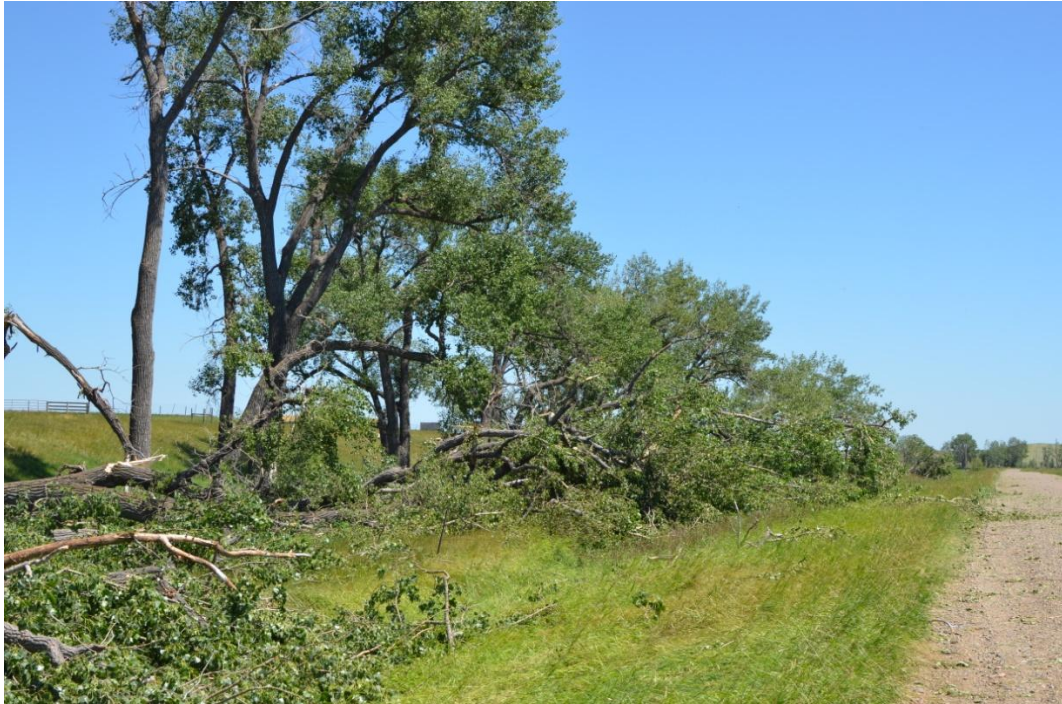
Figure 4. Line of trees down along Rd 115 southeast of Lambert

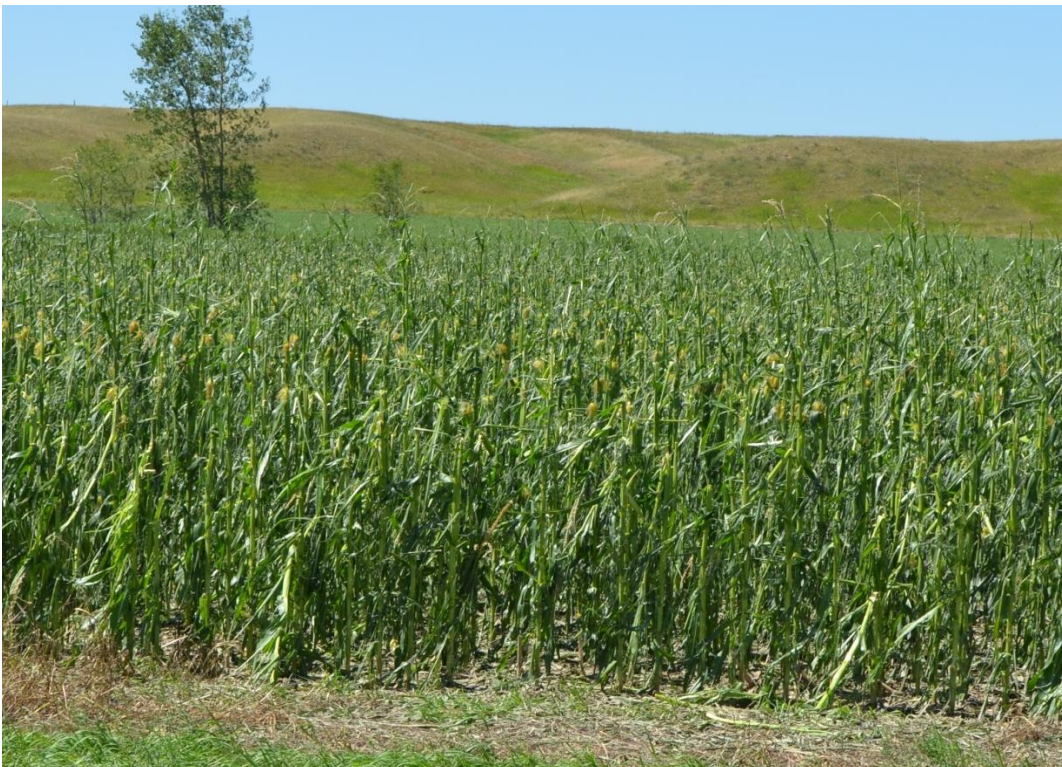
Major to minor crop damage was seen over a large area from 9 southeast of Lambert to Savage (Fig. 5). An irrigation system was destroyed just north of Savage (Fig. 6). There was some damage to structures in and near the town of Savage, with the most significant structural damage surveyed occurring on a ranch 6 miles west-northwest of Savage (Fig. 1 and Fig. 7). At this location, an attached garage was destroyed with the garage door torn off and a wall blown out. Fig. 7 shows the garage door and wall, which were blown 200 feet down wind of the house. Also, this ranch had a grain bin torn off its foundation and blown a half mile down wind, where it was found in a mining pit.

Figure 5. Crop damage near Savage, MT.

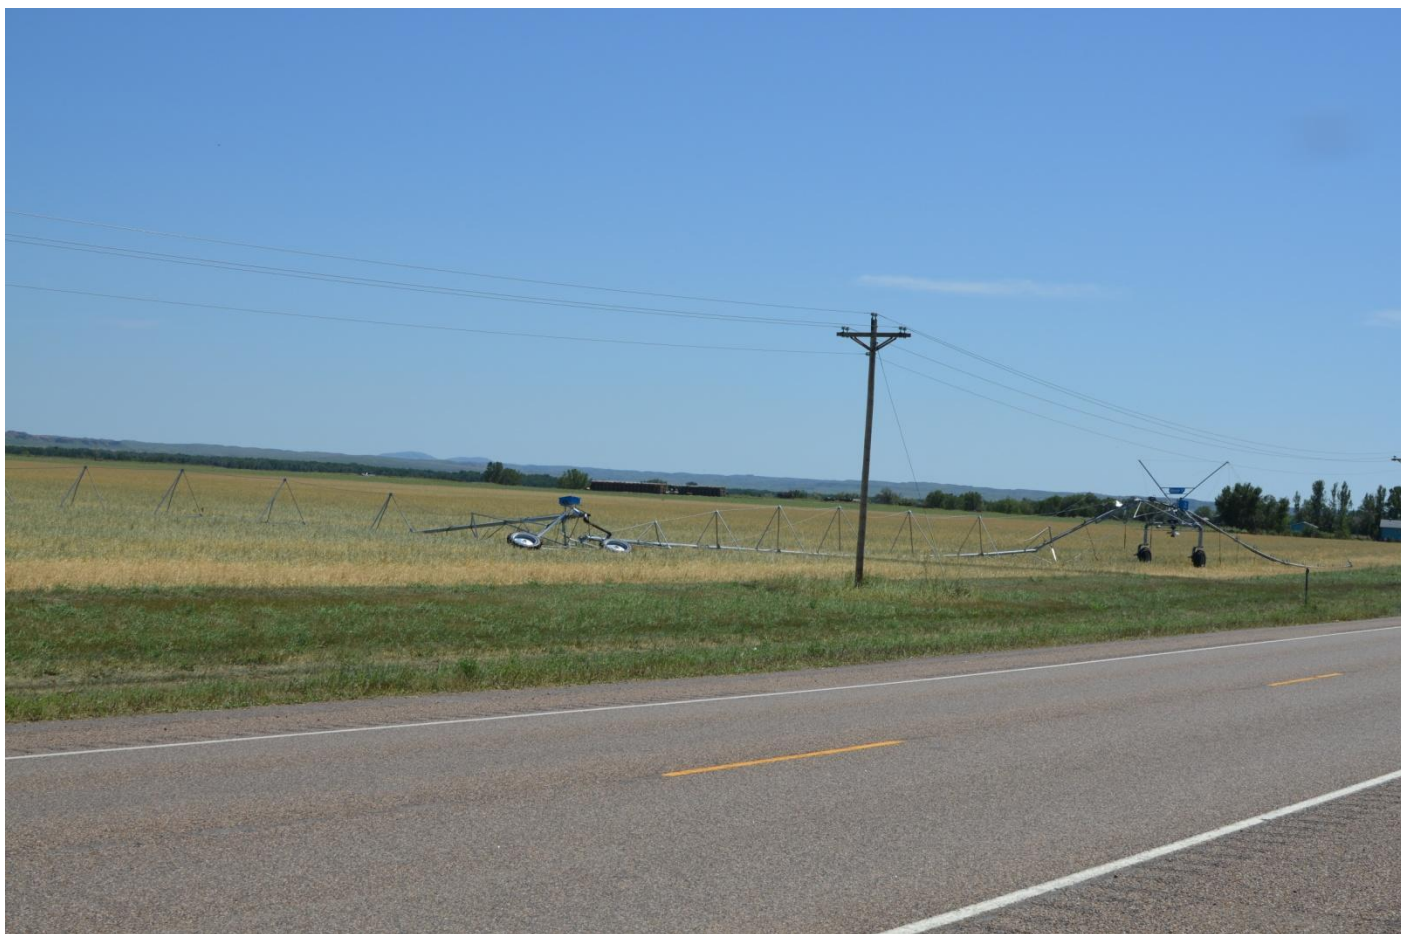
Figure 6. Damaged irrigation equipment north of Savage, MT.

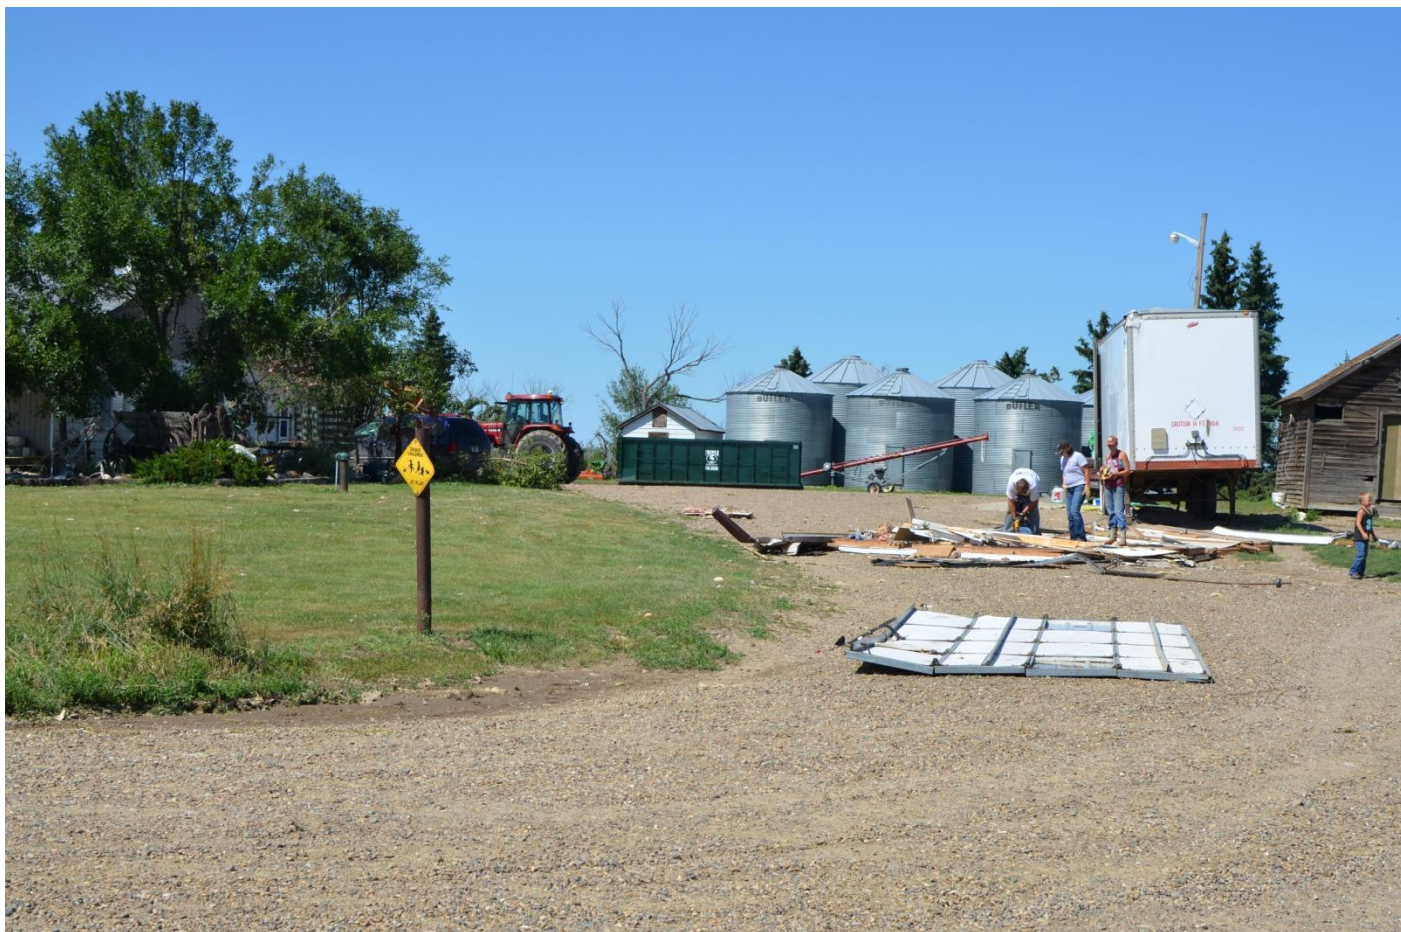
Figure 7. Wall and door torn off of garage attached to house on the left of the image.

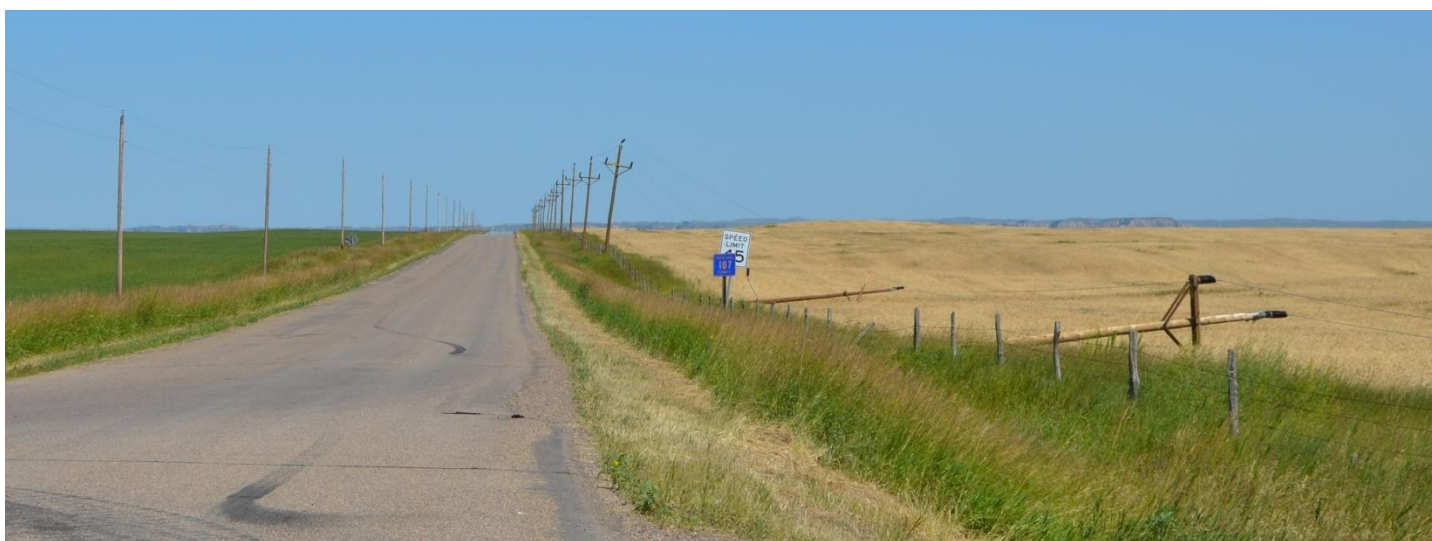
About 4 miles of power poles were blown down or snapped along Rd. 107 west of Lambert (Fig. 8). Figure 8 shows that the poles on the south side of the road were blown down, while those on the north side were not, even though those on the south side were thicker poles. The poles that were blown down were a little taller than those that did not get blown down, and had cross members near the top.

Figure 8. Power poles down along Rd. 107 west of Savage, MT.

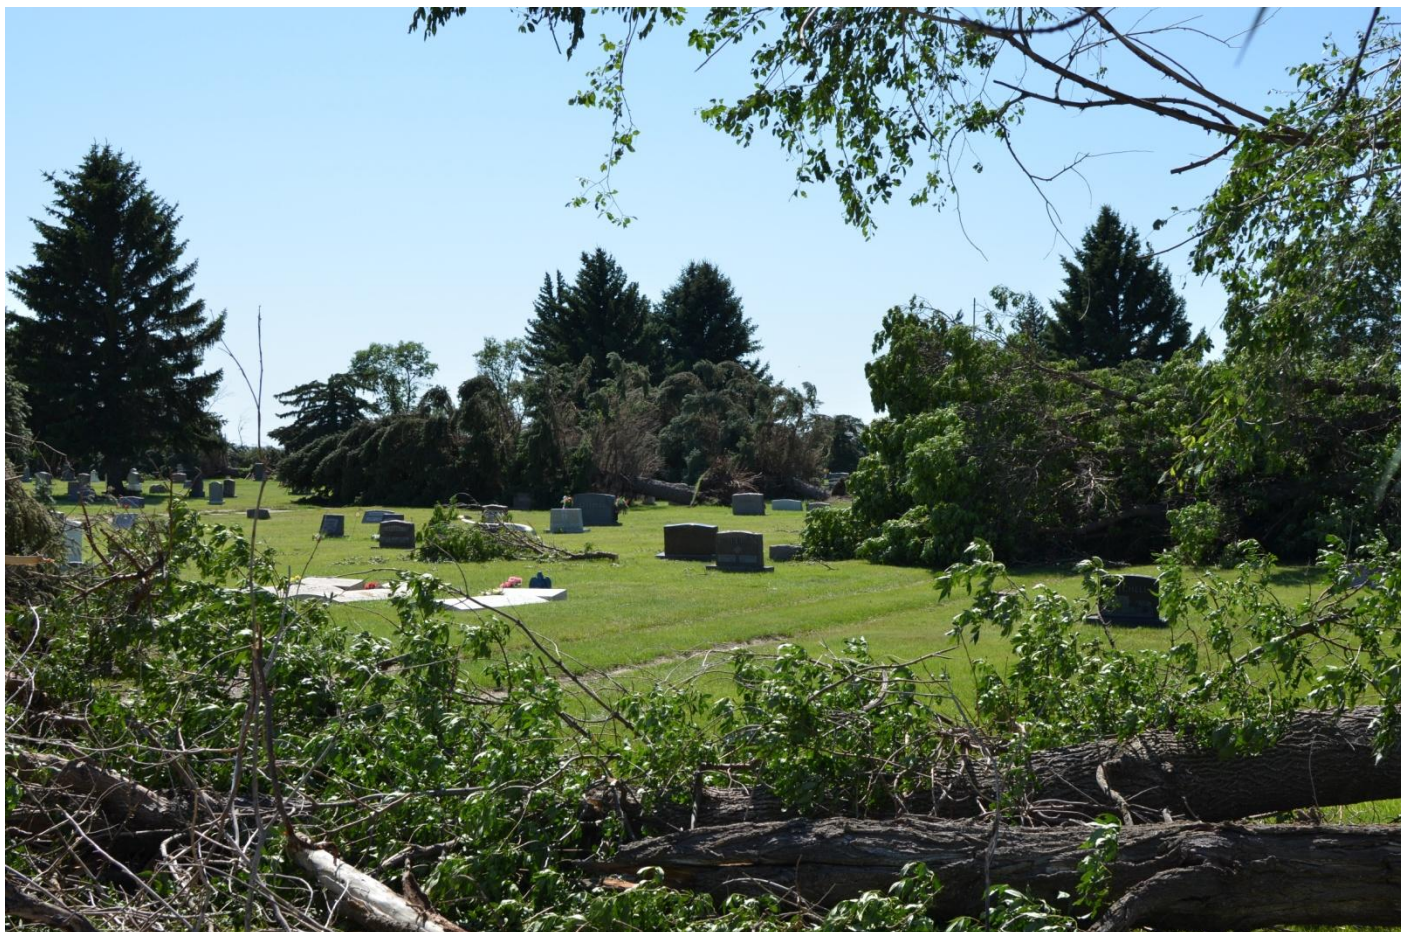
In the town of Savage, numerous trees were uprooted or snapped. Figure 9 shows the cemetery at Savage, where most of the trees were blown down.

Figure 9. Trees down in Riverview Cemetery, Savage, MT.

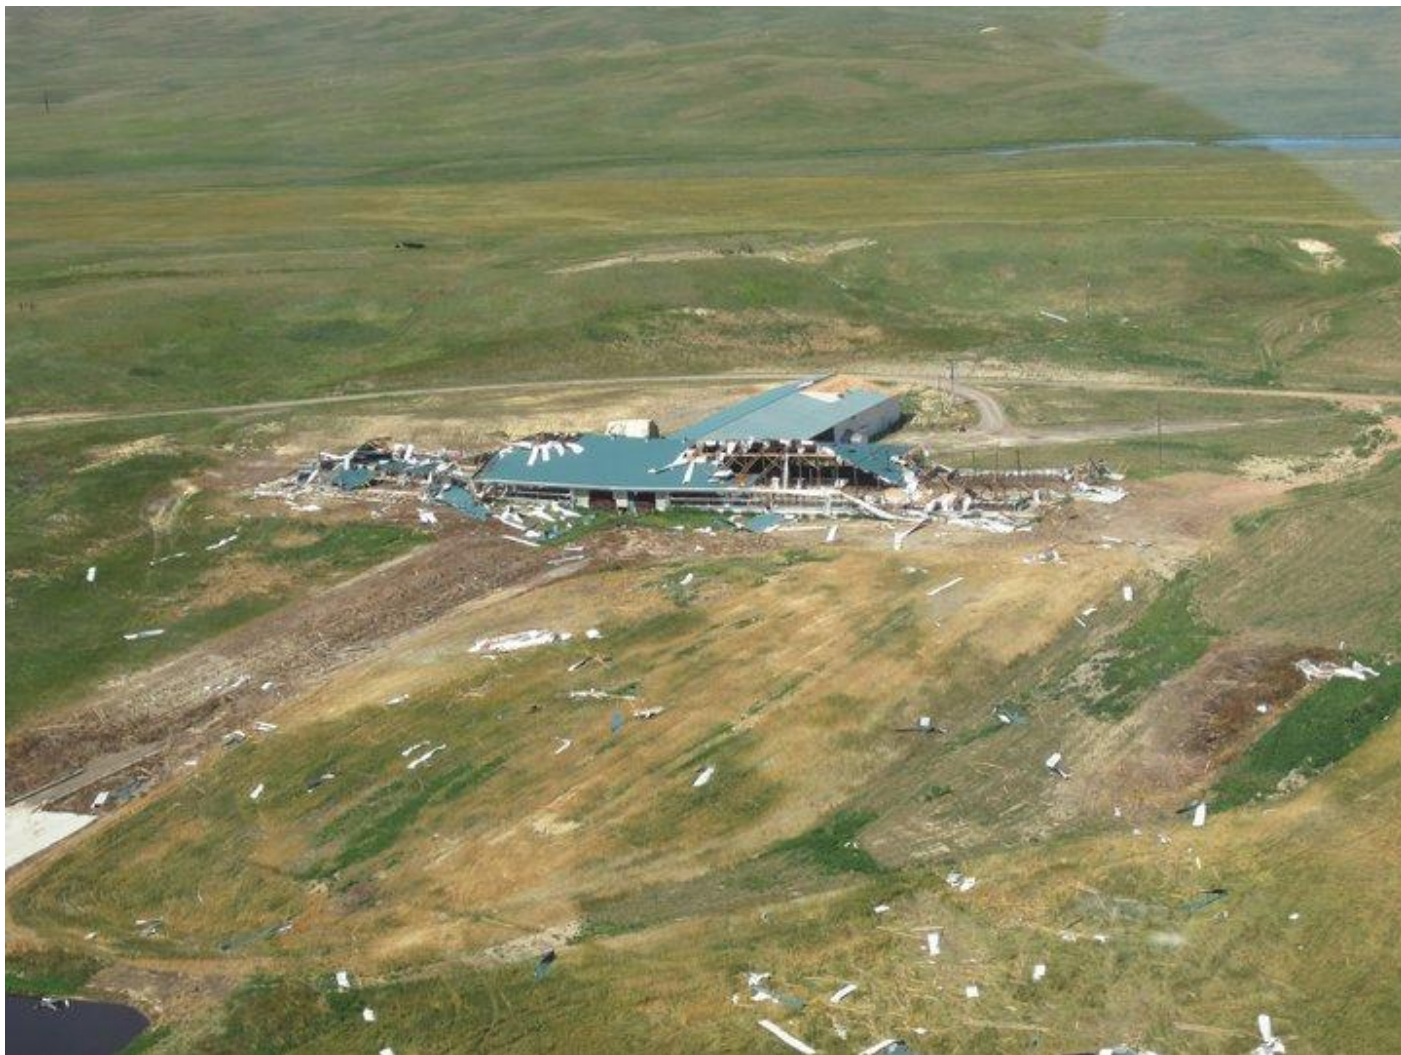
Crop damage occurred as far south as County Road 107, with hail also being reported. However, significant structural and tree damage was reported by the public (not surveyed) further south, without hail also being reported. Figure 10 shows a dairy 2.4 miles west-southwest of Savage with considerable damage and Figure 11 shows a metal cable tower that was topped on County Road 105. All of the debris from the dairy in Fig. 10 appears to have been blown down wind towards the south.

Figure 10. Greenway Dairy 2.4 miles west-southwest of savage. North is towards the upper right of image. Debris was blown towards the south. Photo courtesy of D. J. Roberts.

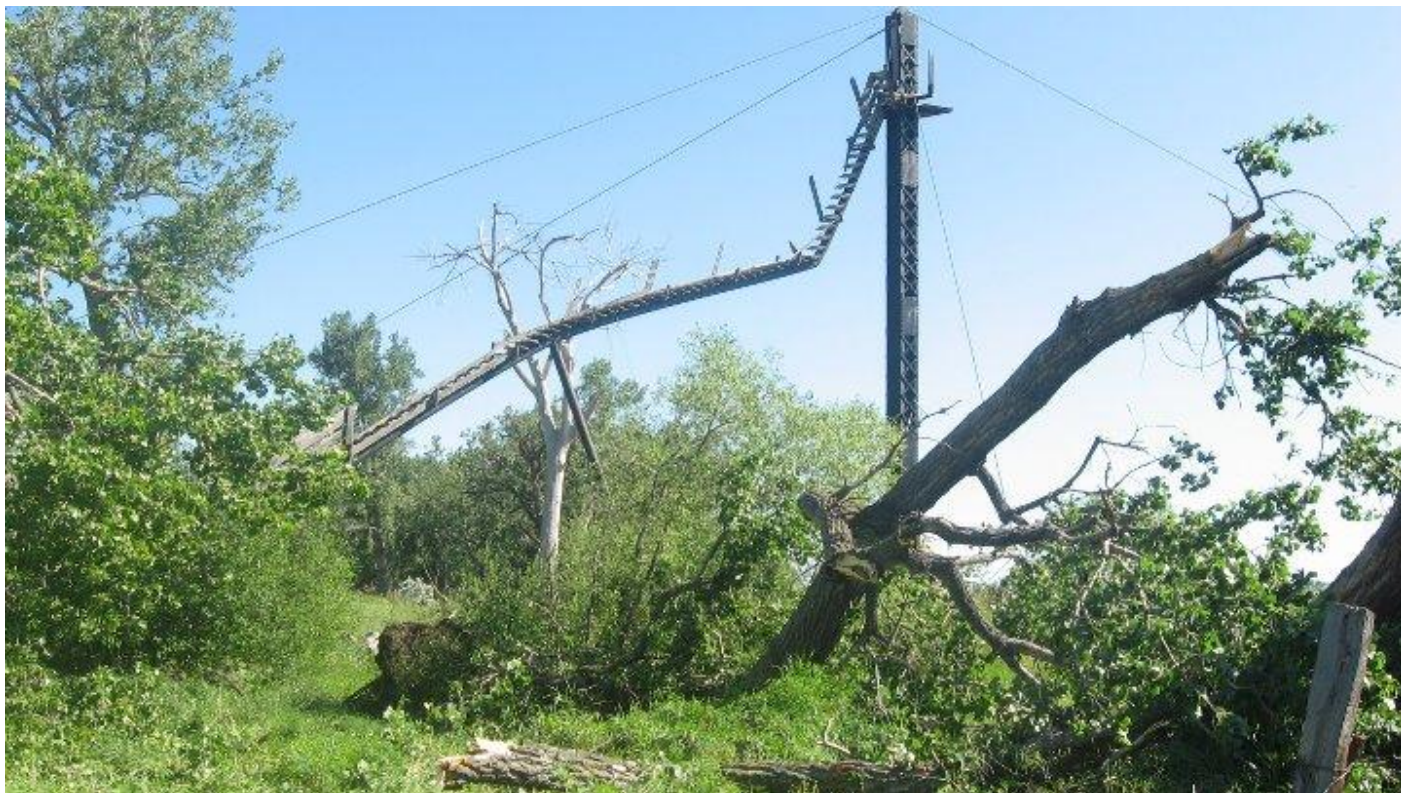
Figure 11. Damaged metal tower on Co. Rd. 105 about 2 miles southwest of Savage, MT. Image courtesy of Charity Schmierer.
